At your request, a visit was made to the referenced address on May 13, 2026, to inspect specific structural concerns noted in a recent home inspection report for the house that you are under contract to purchase. Public property records indicate this house was built in 1973. The following items were noted at the time of the inspection. All directions are in reference to a person facing the front of the house from the street.

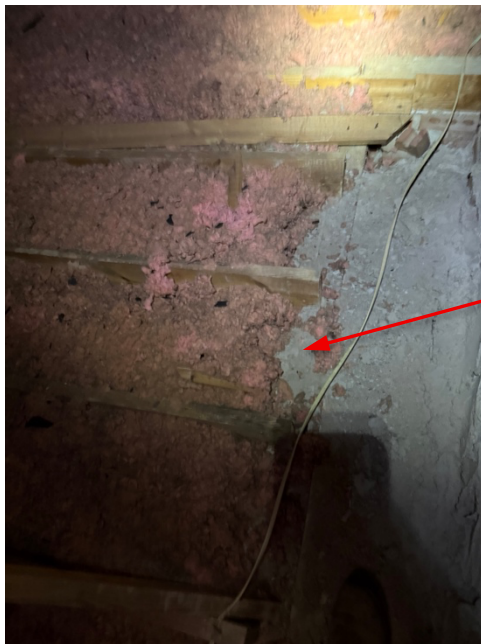
1. The home inspection report indicated a missing roof brace forward of the main center chimney. The roof framing in this area consists of 2x6 rafters spaced at 16 inches on center spanning a horizontal projected distance of approximately 13 feet 6 inches. This span is acceptable under current building code requirements for roof rafters without the need for intermediate bracing. Accordingly, no additional intermediate roof bracing is considered necessary. While inspecting this area, however, it was noted that the ceiling joists forward of the chimney do not have adequate blocking to brace them against rotation. A 2x6 band should be installed to tie the joists together over the top of the wall plate, or alternatively, solid blocking should be installed between the joists at this location. See the photo below.

Add blocking between  
joists

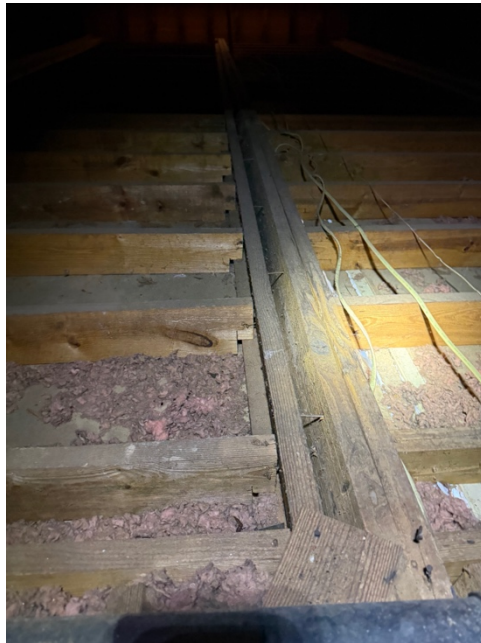
2. The ceiling framing over the garage consists of 2x6 ceiling joists framing into a center triple 2x8 girder. The girder plies have separated substantially, compromising the connection between the ceiling joists and the girder. As a result, the garage ceiling has cracked significantly. Measurements taken within the garage indicate that the front wall

is leaning outward approximately 1.25" to 1.5 inches, while the rear wall containing the garage doors remains plumb. Cracking observed in the front foundation wall suggests that the front footing has rotated outward rather than settled vertically. This condition has caused the top of the wall to pull outward, which in turn has contributed to the separation of the center garage girder and has been further exacerbated by the tension forces imposed by the roof framing. The existing connection at the center girder did not provide sufficient tensile capacity to restrain the top of the front wall against this movement.

This type of footing rotation is commonly associated with poor drainage conditions. Much of the front foundation wall was concealed by vegetation at the time of the inspection and should be cleared to expose the base of the wall. A qualified moisture mitigation specialist should evaluate drainage along the front side of the house and implement corrective measures to ensure that water is directed rapidly away from the foundation. Although the cracks in the front foundation wall are likely attributable to this footing movement, there is no indication that the underlying soils are soft or have inadequate bearing capacity. Accordingly, underpinning repairs are not recommended at this time. Improved drainage should help prevent further movement.

*Girder ply separation*

The ceiling framing over the garage is in a condition that presents a risk of collapse if not repaired. The existing girder should be removed and replaced with a wider multiply girder in accordance with the attached repair detail.

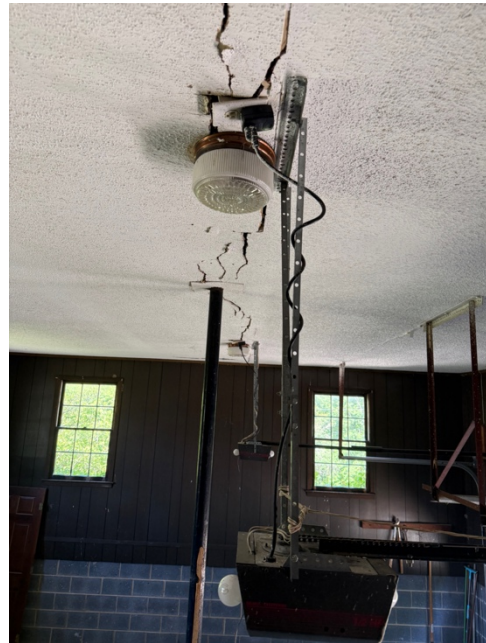
*Resulting crack in ceiling*

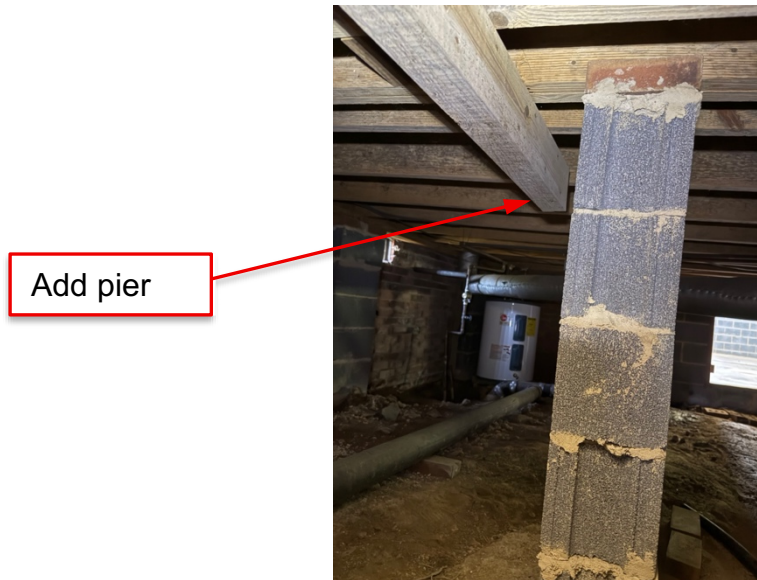
3. In the crawlspace, the intermediate dropped girder beneath the center of the front living room is not supported at either end. A masonry pier should be added at each end adjacent to the existing piers that were likely intended to support the girder. A similar condition exists at the intermediate dropped girder located to the right of the foyer. Each

end of this girder should also be supported with a masonry pier (4 piers total). Each pier should bear on 22"x22"x7" concrete footings. See the photo below.

Add pier

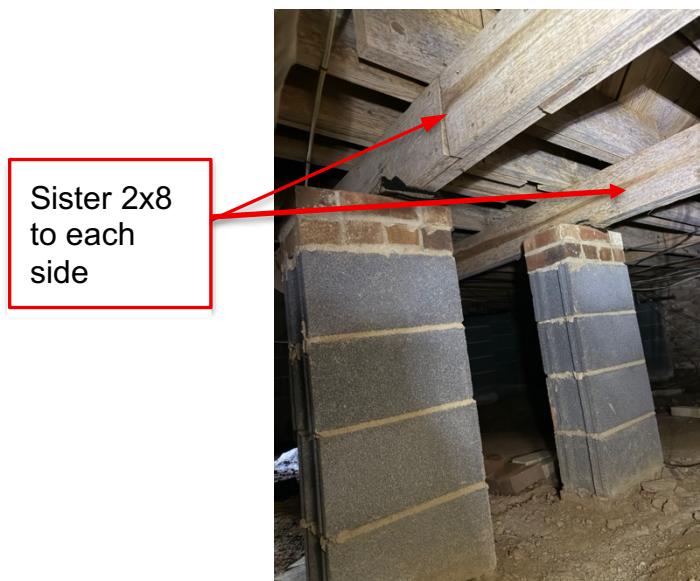
4. The two center dropped girders to the left of the chimney are spliced at locations beyond the supporting pier, creating a structural weakness. In addition, the spans to the left of the piers are approximately 11 feet, which is excessive for the tributary loads imposed on these members. To correct these deficiencies, sister a 2x8 member to each side of both spliced girders to the left of the chimney. In addition, construct a masonry pier at the midpoint of the 11-foot span of each girder, bearing on a 22-inch by 22-inch by 7-inch concrete footing. These new piers will reduce the effective span to approximately 5 feet 6 inches, which is more appropriate for the applied loads.

Sister 2x8  
to each  
side

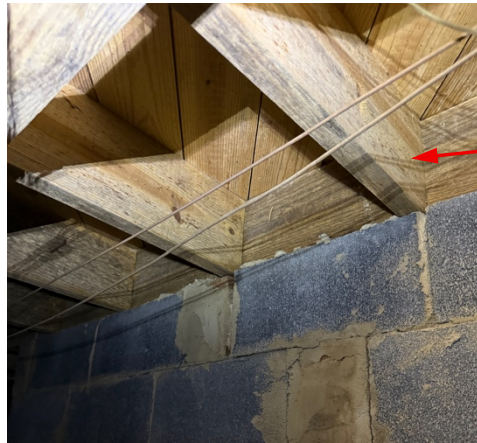
5. The floor joists framing into the rear of the chimney do not have adequate bearing and are not properly connected to the band joist. Install two Simpson Strong-Tie A35 clips at each joist, one on each side, using No. 9 x 2 1/2-inch Simpson Strong-Tie SD Connector Screws. A similar condition exists at the joists located at the front of the

fireplace. Similar brackets may be used at these locations, or a Simpson Strong-Tie LUS28Z joist hanger may be installed instead.

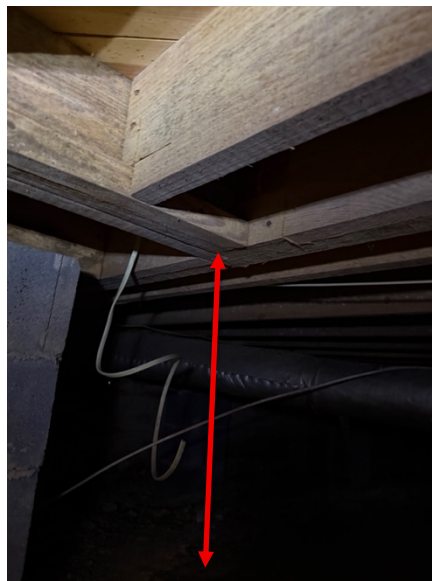
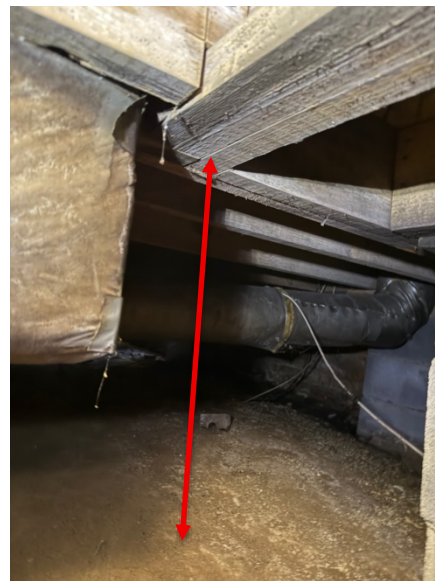
6. The two middle girders to the right of the fireplace are spliced at locations that do not bear over masonry piers. Similar to item #4, sister a continuous 2x8 member from pier to pier along each side of both girders to restore structural continuity.
7. At the front entry, the header spanning left to right is inadequately supported at both ends. Construct a masonry pier beneath each end of this header to provide proper support.
