At your request a visit was made to the referenced address on May 4th, 2026 to inspect the structure, with particular attention to items recently noted in a prior home inspection report. Public property records indicate this house was built in 1977. With homes of this age, one can expect there to be some framing conditions that do not meet today's Code requirements. With that in mind, the repairs recommended in this report are intended to prevent further deterioration and address damaged areas or areas of insufficient support that may influence the safety and performance of the structure under normal use. The following items were noted at the time of the inspection with any photos relevant to that item immediately following:

Garage Ceiling Repair Plan

**Structural  
Drawings**

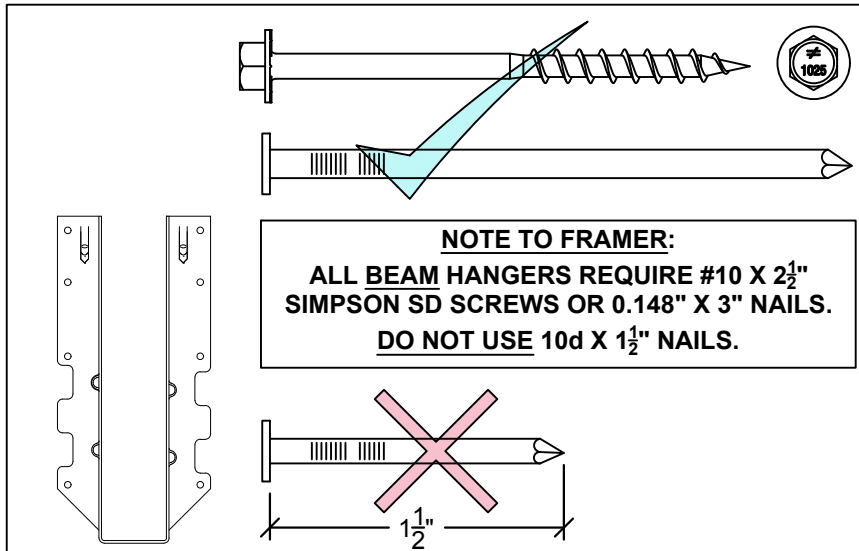
**2**  
**S1** GARAGE ROOF FRAMING PLAN  
SCALE: 1/4" = 1'-0"

3. The ceiling over the garage exhibits a significant sag, which is attributable to overspanned ceiling joists running laterally across the garage. The original construction attempted to create a site-built truss system; however, the geometry of the roof prevents this system from functioning as intended. As a result, the roof and ceiling framing over the garage has sagged, is deficient, and requires reinforcement. Installation of properly designed beams within the garage ceiling is necessary to adequately support the roof structure, consistent with the referenced repair approach. See the attached repair plan for further information.

1. ROOF BRACING SCHEDULE UNO.  
 UNDER 7'-0" = 2-2X4 NAILED WITH 0.131"X3" NAILS @ 6" O.C. VERT.  
 OVER 7'-0" = 2-2X6 T-BRACE (SAME NAILING)  
 OVER 12'-0" = 3-2X6 T-BRACE (SAME NAILING)  
 FASTEN BRACES AT BOTTOM & TOP WITH (4)-0.131"X3" TOENAILS.
